Case Study

Rural Private Residence

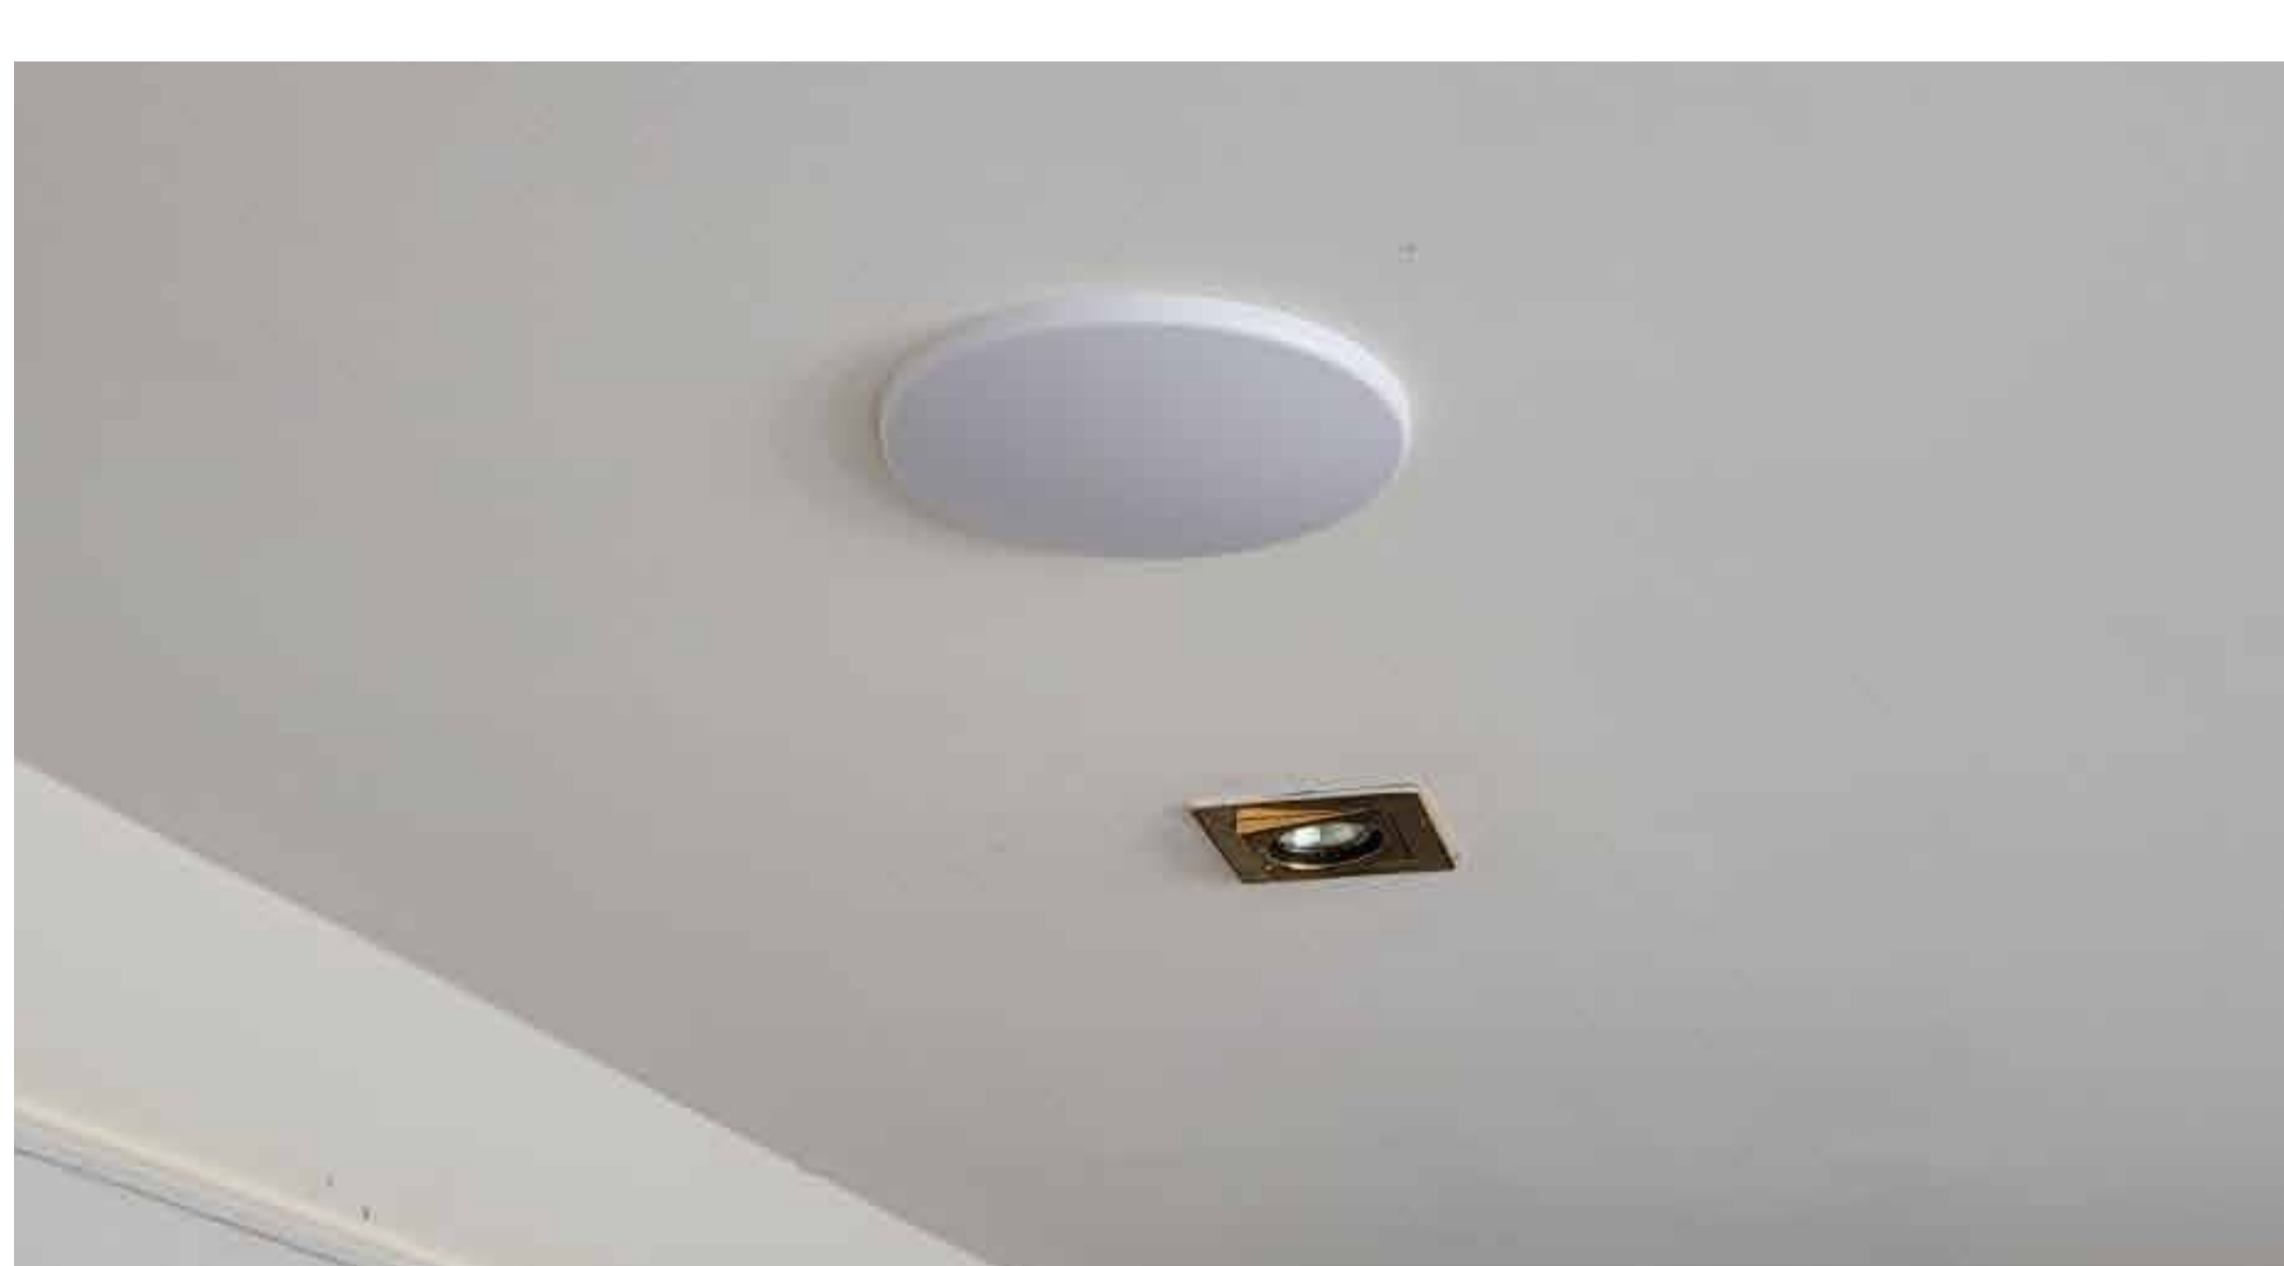
Mobile Signal Solutions engineers used a high-level spectrum analyzer to align a high-gain donor antenna at roof level to the strongest available frequencies. A commercial-grade booster system was installed to simultaneously amplify five channels, addressing the poor signal issues. The amplification power was increased to the maximum allowed in the UK, minimizing the number of internal antennas needed.
